Client:
The Rosebery Group

Site:
12 MW Datacentre

Location:
The Wirral, Merseyside, UK

3C Overheating Protection in a Datacentre

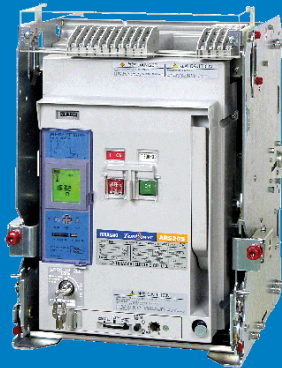
TemPower 2 ACB,
TemBreak 2 MCCB and
TemTransfer 2
Automatic Changeover
Controller

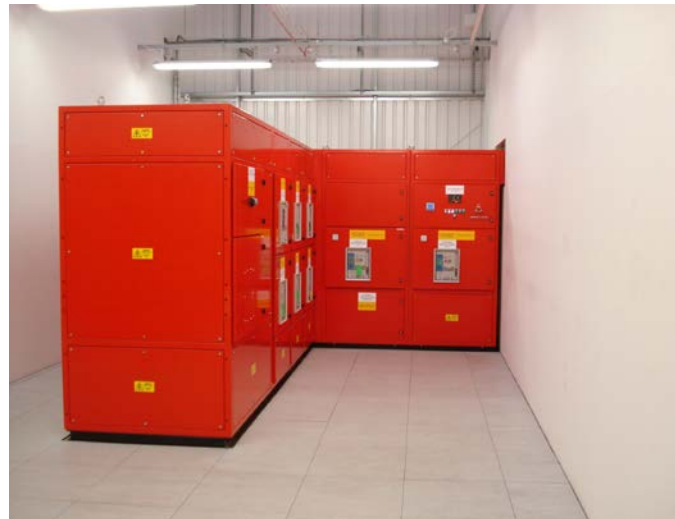
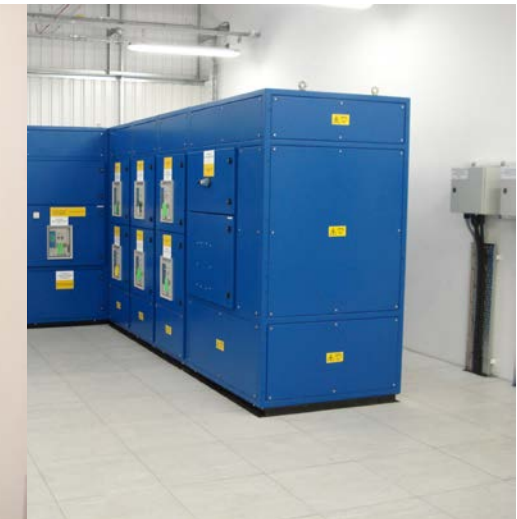
The Rosebery Group used Terasaki's 3C Overheating Protection in the switchboards for a 12 megawatt datacentre (pictured below). 3C is overheating protection for **C**ontacts, **C**onnections and **C**onductors. The following Terasaki products were used:

ACBs: one integrated NTC thermistor per phase. "Overheat" alarm on integrated display of breaker + "overheat" alarm contact + "overheat" alarm delivered to Building Management System via Modbus

Outgoing circuits: temperature sensors integrated with line and load terminals of MCCBs. "Overheat" alarm contact + LED indication
